# BRISBANE AIRPORT RUNWAY HIAL STRUCTURE

## RESTORING CRITICAL MARINE INFRASTRUCTURE IN AN OPERATIONAL AIRPORT ENVIRONMENT

IPCQ was engaged by Brisbane Airport Corporation to complete restorative coating works to the Runway 19R High Intensity Approach Lighting (HIAL) Marine Structure. The project involved corrosion remediation and protective coating application to critical steel infrastructure supporting airfield lighting systems, ensuring the structure continues to meet its intended 50-year design life while operating within a highly regulated airport and marine environment.

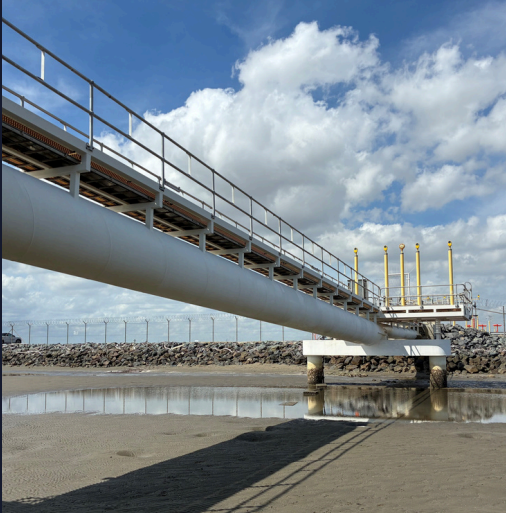
01

The project required restorative coating works to be completed within a complex marine and operational airport environment.

- Working over water & tidal zones
- Maintaining airport operational safety requirements
- Strict environmental protection controls
- High QA and inspection requirements
- Corrosion remediation in a severe marine environment
- Accessing elevated and restricted infrastructure

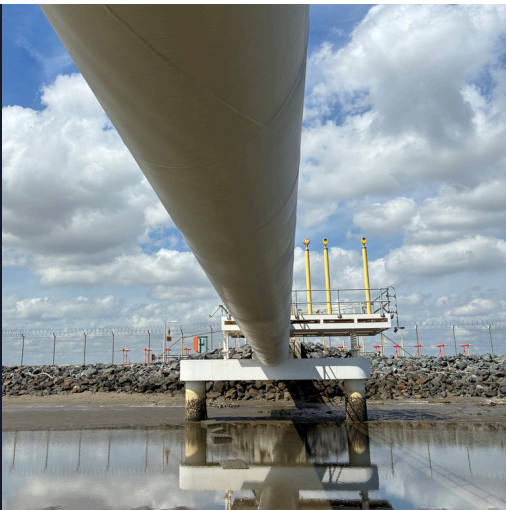
03

IPCQ successfully restored protective coating systems on critical Brisbane Airport infrastructure, supporting long-term asset performance, safety and operational reliability.

- Protection of critical HIAL infrastructure
- Supporting the intended 50-year design life
- High-quality coating restoration outcomes
- Zero safety incidents throughout delivery
- Environmental compliance maintained
- BAC CEO Safety Award nomination
